## Faulty Crowns Corrected by all Ceramic Crowns – A Case Report

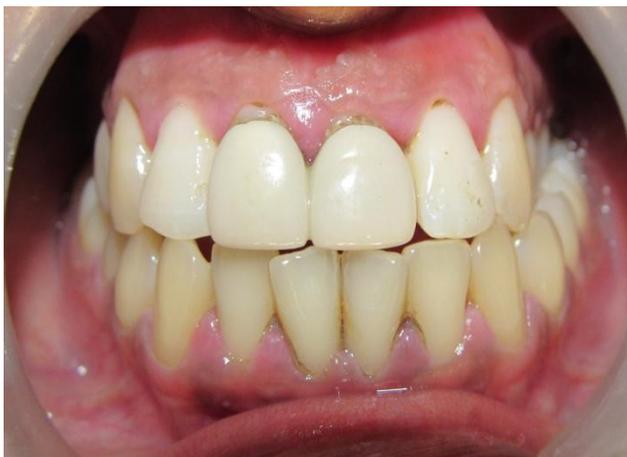
A young female patient aged 23 years reported to the department of prosthodontics with a chief complaint of poor aesthetics of two maxillary front crowns fabricated 3years back by a local dentist.

**Figure 1: Maxillary central incisors with joined crowns and cervically exposed root surfaces**

included removal of the two faulty crowns followed by modification of tooth preparation and definitive restoration in the form of all ceramic crowns. The patient consented to the treatment option while rejecting alternative metal ceramic crowns.

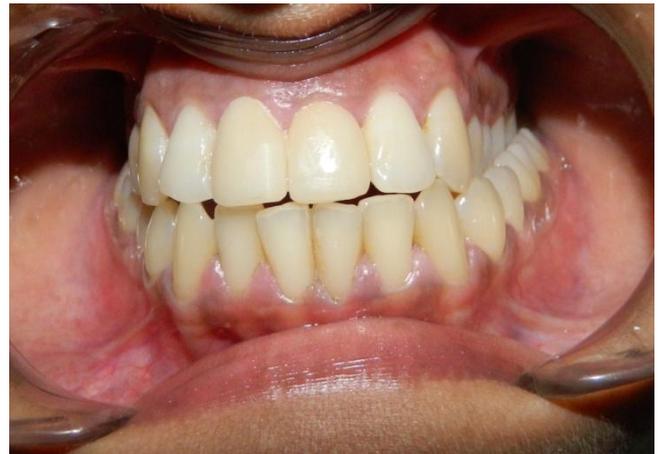
**Figure 2: Modified tooth preparation cemented with temporary crowns**

The clinical procedures for fabrication of a single crown were routine. After removal of faulty crowns, the tooth preparation was modified with extension of margins just below the free marginal gingiva. A temporary restoration was fabricated from self cure tooth colored resin (Unifast) and cemented with a temporary cement (Fig 2). Final impressions were made using a dual mix technique on a custom tray. After a coping trial and shade selection, the definitive crowns were cemented with a resin cement (Fig 3). The patient was instructed regarding oral hygiene maintenance of the single crowns. The patient was highly satisfied with the esthetic outcome of the two cemented crowns (Fig 3).

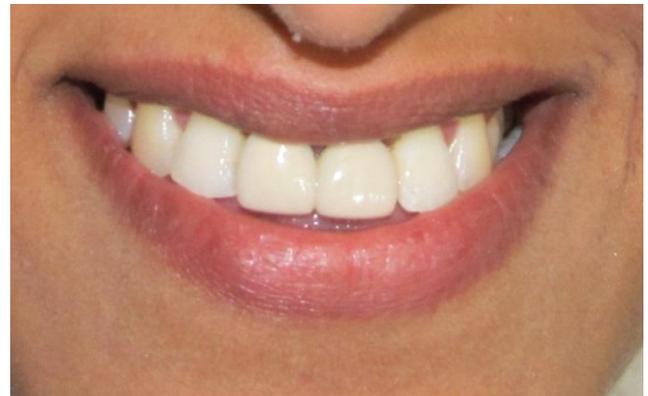
**Figure 3: Definitive all ceramic crowns cemented in place.**

Zirconia coping was fabricated using a CAD/ CAM, while laser scanner (Cynoprod/Canada) scanned the preparation. Besides esthetics in terms of translucency and vitality, the all ceramic crown material has excellent strength, corrosion resistance and biocompatibility.<sup>5,12</sup>
